Development of a Seismic Design Methodology for Precast Diaphragms - PHASE 1 SUMMARY REPORT

PCI / NSF Project

PHASE 1
SUMMARY REPORT

ATLSS REPORT NO. 06-03

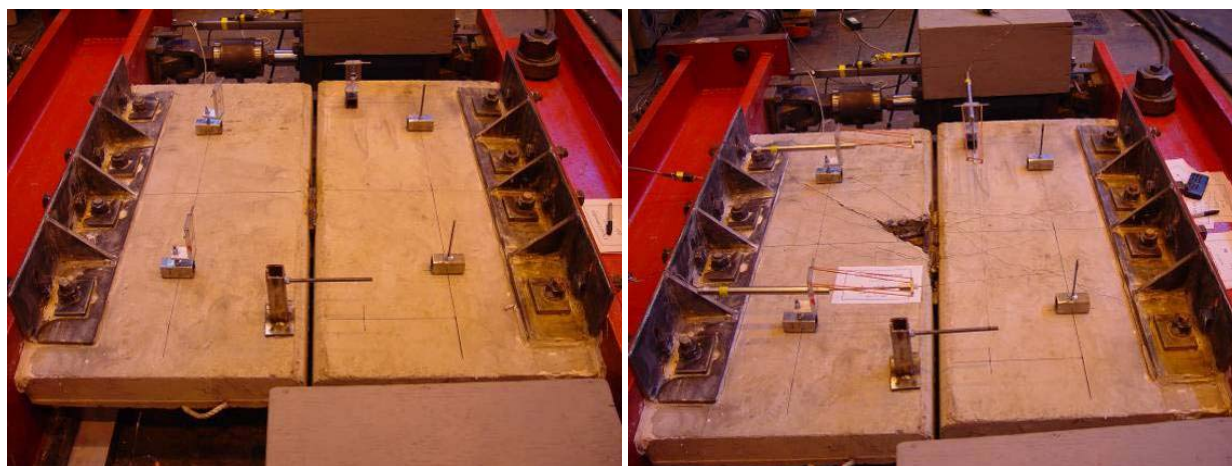
Figure B-4.1: Damage state at 0 and +0.96-in. shear deformation

The performance of an pre-topped welded chord connector subjected to cyclic shear is presented in this section. The panel was subjected to shear displacement with the tensile displacement restrained, $\Delta T=0$. Panel failure consisted of diagonal cracking from the connector to the support in both panels followed by local cracking at the connector face in the free panel and finally fracture of one connector bar in the free panel. The observed events and corresponding displacement cycle is presented in Table B-4.1. The photos of the damage are presented in Figure B-4.1. The global force deformation response and backbone curve is presented in Table B-4.2 and Figure B-4.2.

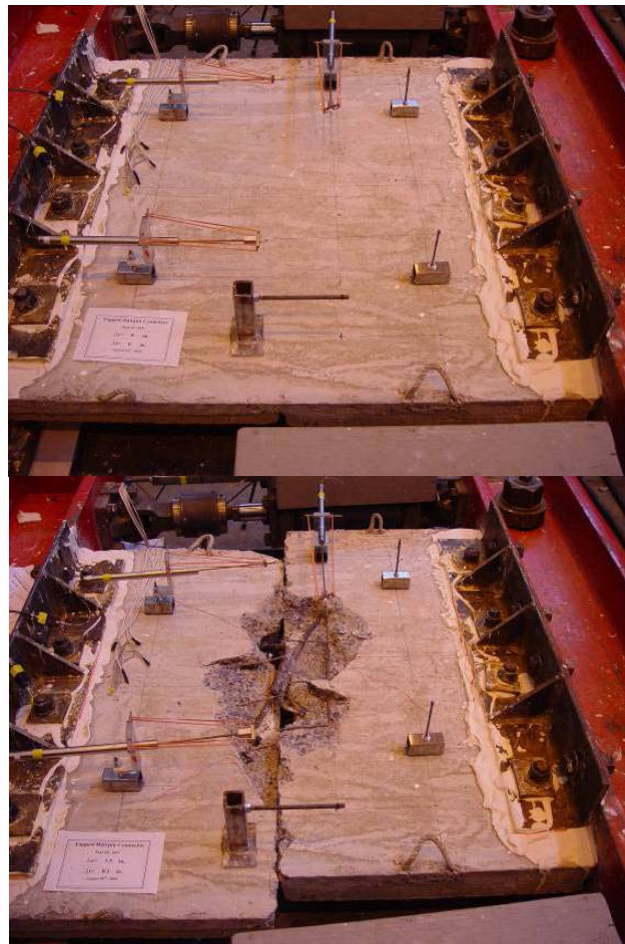
Figure D-3.1: Damage state at 0 and 3.5-in. shear opening

The performance of a topped hairpin web connector subjected to monotonic shear was repeated to provide further information on the ultimate deformation capacity. The panel was pre-cracked by applying a tensile opening of 0.1-in. A shear displacement was the applied with the tensile displacement restrained at the 0.1-in. opening. Panel damage consisted of diagonal cracking from the connector to the support in both panels followed by fractures of the WWR in the topping and finally, fracture of the tension leg in the free panel close to the weld toe. The observed events and corresponding displacement cycle is presented in Table D-3.1. The photos of the damage are presented in Figure D-3.1. The global force deformation response and backbone curve is presented in Table D-3.2 and Figure D-3.2.

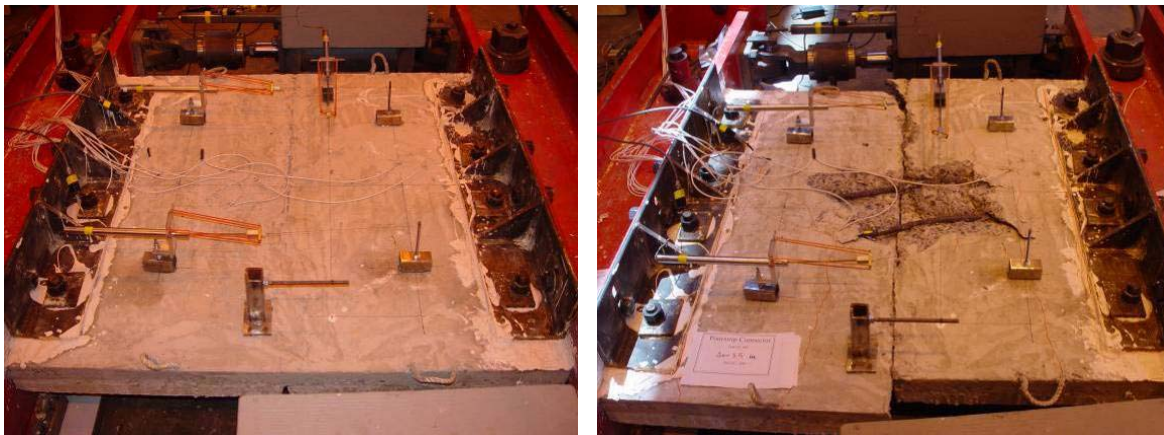
Figure F-2.1: Damage state at 0.5 and 3.5-in. shear opening
